**Flood Control Project Maintenance
Levee Inspections**
LMA District Cover Sheet
Spring 2017 Levee Inspection Results

Reclamation District No. 0536 Egbert

Spring 2017 Levee Inspection Results

Waterway			Bank	Unit Miles
Unit No. 01 Lindsey Slough			Right	5.58
	Spring (March - May)	Summer (June - August)	(September - November) Fall	Winter (December - February)
Unit Maintenance Rating (Fall Only)				
Date of Inspection	4/11/2017 - 4/11/2017			
DWR Inspector	Herman Phillips			
Accompanied By

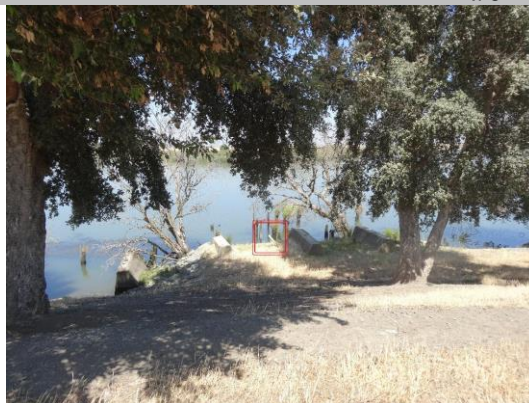
Photo 1 of 2 : UCIP_SP_2017_20544_34625.jpg

LM Start	5.12	Rating **	M	Issue No.	76
LM End	5.12	Issue Type +	En	Location *	WS
Category	Supplemental			GPS Latitude/Longitude	
				Start	End
Item	DWR UCIP Field Study			38.245588 °	38.245588 °
				-121.705723 °	-121.705723 °
DWR ID					
Comment Code					
Inspector Comment					
FS_ID:20544 DS_ID:24024 EP_NO: N/A Repair Type: Non-Urgent Crossing Status: Found UCIP Comments: - field discovered pipe.- seems abandoned pipe. Needs proper abandonment. FIELD_STRUCT_DESC: *ABANDONED* 6-inch galvanized iron pipe on top of concrete pad and through levee. Details not available. FS Date: 8/13/2013

WS view: overview of levee slope, concrete pad, and pipe.

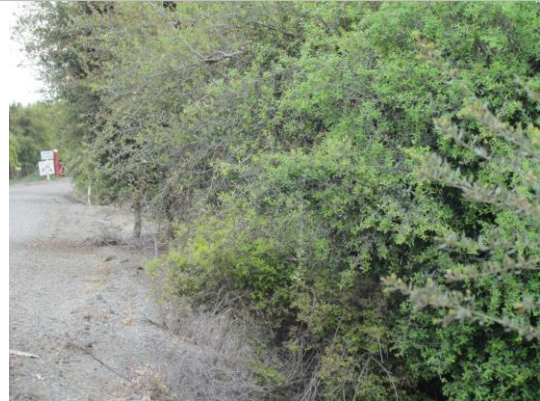
Photo 1 of 1 : SP_2017_RD0536_208_65_20170519_00053.jpg

LM Start	5.17	Rating **	U	Issue No.	65
LM End	5.39	Issue Type +	Ma	Location *	LS
Category	Earthen Levee			GPS Latitude/Longitude	
				Start	End
Item	Vegetation			38.245300 °	38.245742 °
				-121.704909 °	-121.700893 °
DWR ID	DWR_RD0536_01_s_2014_65				
Comment Code					
V7 : Trees / Woody Vegetation					
Inspector Comment					
These young oak trees need to be removed from the landward slope and shoulder before they get any larger.

RD 536 Unit 1 levee mile 5.17-5.39.

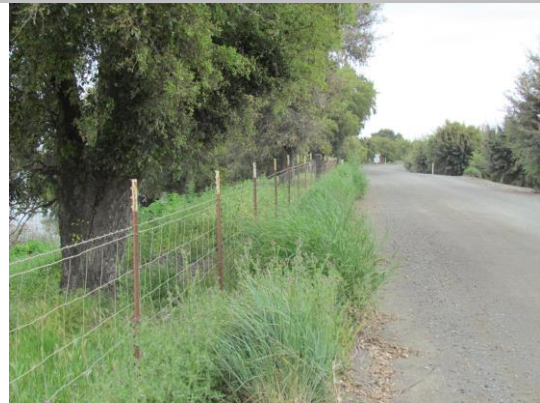
Photo 1 of 1 : SP_2017_RD0536_208_26_20170519_00052.jpg

LM Start	5.20	Rating **	U	Issue No.	26
LM End	5.57	Issue Type +	Ma	Location *	WS
Category	Earthen Levee			GPS Latitude/Longitude	
				Start	End
Item	Vegetation			38.245272 °	38.245613 °
				-121.704460 °	-121.697740 °
DWR ID	DWR_RD0536_01_f_2016_26				
Comment Code					
V1 : Control annual grass and weeds on the levee slopes and easements.					
Inspector Comment					
Control the wild grasses on the waterside levee slope.

RD 536 Unit 1 Levee mile 5.41-5.57 waterside slope and shoulder.

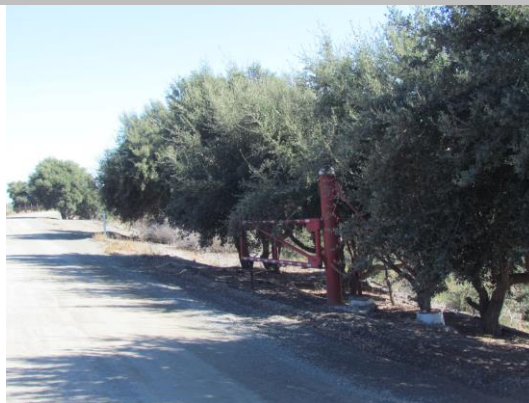
Photo 2 of 2 : SP_2017_RD0536_208_11_20170404_00003.jpg

LM Start	5.34	Rating **	U	Issue No.	11 (cont)	
LM End	5.34	Issue Type +	En	Location *	CR	
Category	Earthen Levee			GPS Latitude/Longitude		
				Start	End	
Item	Encroachments			38.245644 °	38.245644 °	
				-121.701945 °	-121.701945 °	
DWR ID	DWR_RD0536_01_s_2013_11					
Comment Code						
FE : Fence						
Inspector Comment						
The District said that the property owner had this gate and barricade installed by the County.

This gate rest and gate on the landside of the levee shoulder.

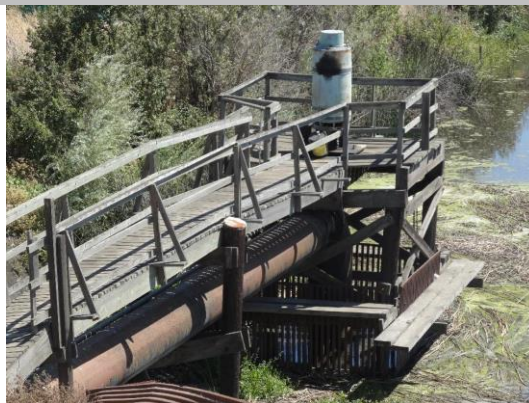
Photo 3 of 3 : UCIP_SP_2017_20563_34644.jpg

LM Start	5.49	Rating **	M	Issue No.	77 (cont)	
LM End	5.49	Issue Type +	En	Location *	CR	
Category	Supplemental			GPS Latitude/Longitude		
				Start	End	
Item	DWR UCIP Field Study			38.245512 °	38.245512 °	
				-121.699119 °	-121.699119 °	
DWR ID						
Comment Code						
Inspector Comment						
FS_ID:20563						
DS_ID:22722						
EP_NO: 7208						
Repair Type: Non-Urgent						
Crossing Status: Found						
UCIP Comments: - siphon breaker needs cover/protection.- service pole on landside of the levee.						
FIELD_STRUCT_DESC: 30-inch steel drain pipe through levee 5.7 feet below crown. Pump in piling structure in drain ditch on landward side.						
Siphon breaker on waterward shoulder. (Permit No. 7208, 1971)						
FS Date: 8/13/2013

LS view: pipe under the wooden walkway and pump on wooden platform in drain ditch.

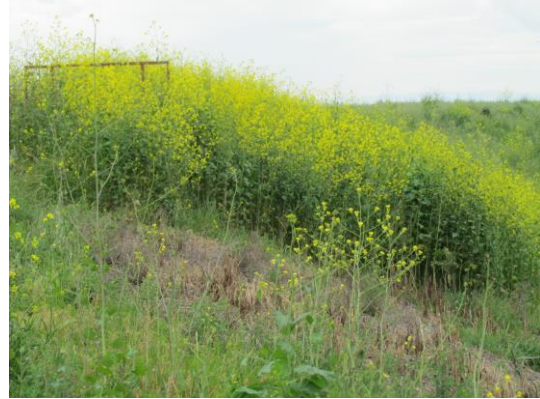
Photo 1 of 1 : SP_2017_RD0536_209_13_20170519_00015.jpg

LM Start	0.09	Rating **	U	Issue No.	13
LM End	4.99	Issue Type +	Ma	Location *	LS
Category	Earthen Levee			GPS Latitude/Longitude	
				Start	End
Item	Vegetation			38.244245 °	38.198783 °
				-121.696995 °	-121.710020 °
DWR ID	DWR_RD0536_02_s_2017_13				
Comment Code					
V1 : Control annual grass and weeds on the levee slopes and easements.					
Inspector Comment					
Remove the wild weed growth from the landside levee shoulder and slope.

RD 536 Unit 2 levee mile 0.09-4.99 Landside slope.

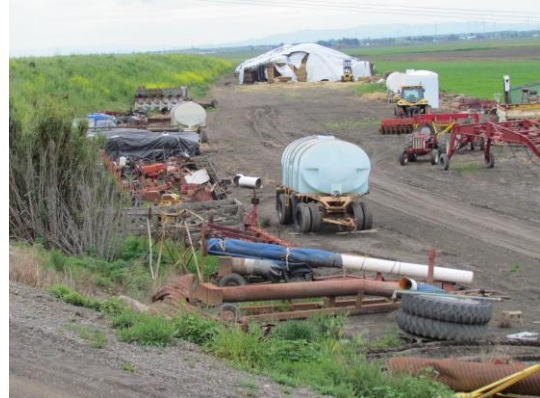
Photo 1 of 1 : SP_2017_RD0536_209_5_20170519_00017.jpg

LM Start	0.09	Rating **	U	Issue No.	5
LM End	0.13	Issue Type +	En	Location *	LS
Category	Earthen Levee			GPS Latitude/Longitude	
				Start	End
Item	Encroachments			38.244240 °	38.243709 °
				-121.696830 °	-121.696934 °
DWR ID	DWR_RD0536_02_s_2012_5				
Comment Code					
EQ : Equipment					
Inspector Comment					
Remove the equipment from the landside easement levee miles 0.09-0.13.

RD 536 Unit 2 levee mile 0.09 landside toe.

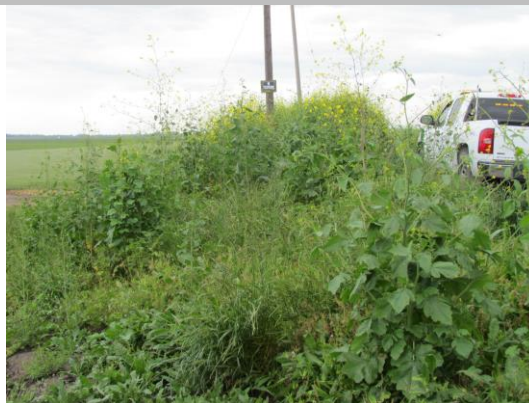
Photo 1 of 1 : SP_2017_RD0536_209_7_20170519_00016.jpg

LM Start	0.10	Rating **	U	Issue No.	7
LM End	4.38	Issue Type +	Ma	Location *	WS
Category	Earthen Levee			GPS Latitude/Longitude	
				Start	End
Item	Vegetation			38.244210 °	38.196720 °
				-121.696975 °	-121.699200 °
DWR ID	DWR_RD0536_02_s_2017_7				
Comment Code					
V1 : Control annual grass and weeds on the levee slopes and easements.					
Inspector Comment					
Remove the unsatisfactory wild growth of vegetation from the waterside slope and toe.

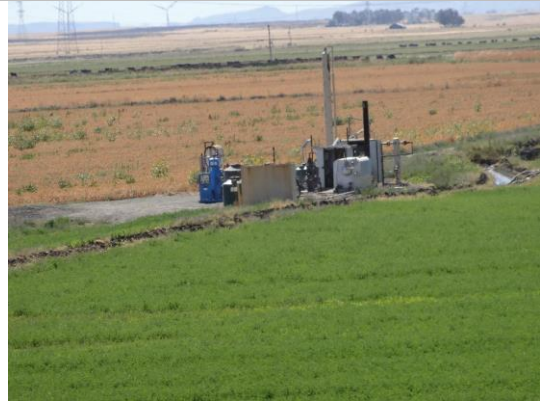
Photo 3 of 3 : UCIP_SP_2017_20664_34744.jpg

LM Start	1.47	Rating **	M	Issue No.	20 (cont)
LM End	1.47	Issue Type +	En	Location *	CR
Category	Supplemental			GPS Latitude/Longitude	
				Start	End
Item	DWR UCIP Field Study			38.224423 °	38.224423 °
				-121.697049 °	-121.697049 °
DWR ID					
Comment Code					
Inspector Comment					
FS_ID:20664 DS_ID:22732 EP_NO: 17829 Repair Type: Non-Urgent Crossing Status: Indicator Found UCIP Comments: Indicator is found only on WS. The indicator is different than standard indicator. Needs more info from LMA/DWR Inspector. FIELD_STRUCT_DESC: 3.5-inch welded steel natural gas pipe through levee 44.0 feet below crown (Permit No. 17829, 2004). FS Date: 8/13/2013

WS view: natural gas extraction plant near levee on the field.

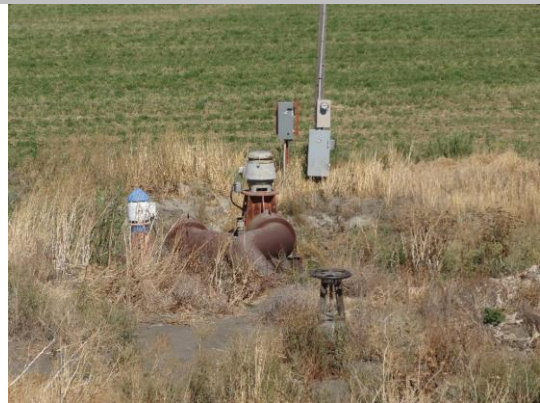
Photo 1 of 2 : UCIP_SP_2017_20647_34731.jpg

LM Start	2.50	Rating **	M	Issue No.	21
LM End	2.50	Issue Type +	En	Location *	CR
Category	Supplemental			GPS Latitude/Longitude	
				Start	End
Item	DWR UCIP Field Study			38.210063 °	38.210063 °
				-121.691768 °	-121.691768 °
DWR ID					
Comment Code					
Inspector Comment					
FS_ID:20647 DS_ID:24025 EP_NO: N/A Repair Type: Non-Urgent Crossing Status: Found UCIP Comments: Needs more info from LMA/DWR Inspector. Pump and pipe looks new. FIELD_STRUCT_DESC: A 12-inch steel pipe with vertical pump on drainage ditch. No other details available. FS Date: 8/13/2013

WS view: overview of pipe and pump (left). Big pump and appurtenances (right) for 24" steel pipe.

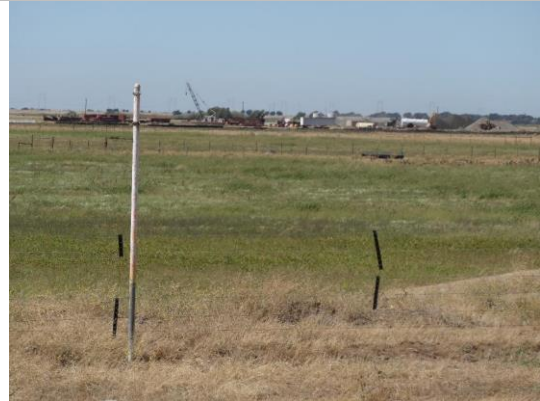
Photo 2 of 2 : UCIP_SP_2017_41845_34764.jpg

LM Start	4.14	Rating **	M	Issue No.	22 (cont)
LM End	4.14	Issue Type +	En	Location *	CR
Category	Supplemental			GPS Latitude/Longitude	
				Start	End
Item	DWR UCIP Field Study			38.195875 °	38.195875 °
				-121.695177 °	-121.695177 °
DWR ID					
Comment Code					
Inspector Comment					
FS_ID:41845 DS_ID:22731 EP_NO: 1217 Repair Type: Non-Urgent Crossing Status: Indicator Found UCIP Comments: Gasline needs markers on both slopes. Existing markers in disrepair. FIELD_STRUCT_DESC: 8.625-inch gas line through levee at unknown elevation (Permit No. 1217, 1947). FS Date: 8/13/2013

LS view: gasline indicator on levee toe.

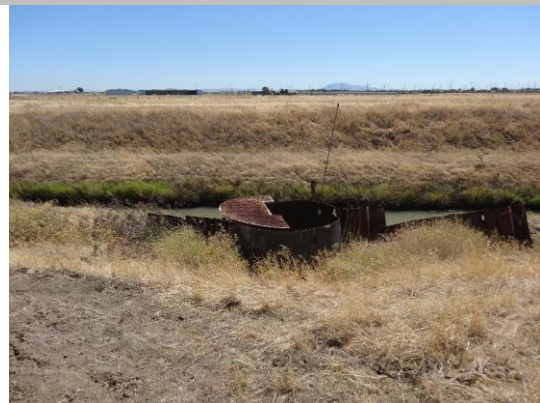
Photo 1 of 3 : UCIP_SP_2017_46813_34768.jpg

LM Start	4.36	Rating **	M	Issue No.	23
LM End	4.36	Issue Type +	En	Location *	CR
Category	Supplemental			GPS Latitude/Longitude	
				Start	End
Item	DWR UCIP Field Study			38.196429 °	38.196429 °
				-121.698962 °	-121.698962 °
DWR ID					
Comment Code					
Inspector Comment					
FS_ID:46813					
DS_ID:22735					
EP_NO: N/A					
Repair Type: Non-Urgent					
Crossing Status: Found					
UCIP Comments: Recommend owner contact CVFPB to provide updated owner info and obtain necessary permit for this crossing.					
FIELD_STRUCT_DESC: 18-inch steel pipe on WS. Steel standpipe on both sides of the levee. Temporary canvas about 2" below crown. Per 2015 Inspection Report provided by Herman Phillips, diesel motor found on WS and owner is Mr. Page Baldwin.					
FS Date: 8/13/2013

WS view: steel standpipe on levee slope.

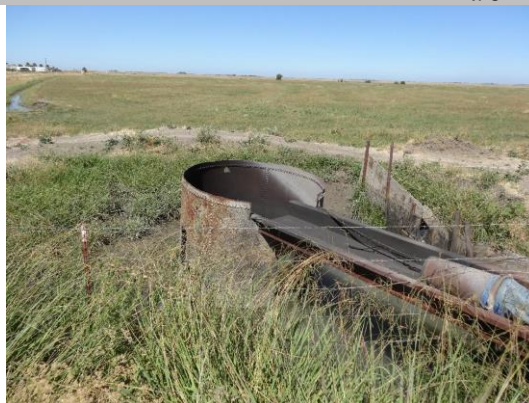
Photo 2 of 3 : UCIP_SP_2017_46813_34767.jpg

LM Start	4.36	Rating **	M	Issue No.	23 (cont)	
LM End	4.36	Issue Type +	En	Location *	CR	
Category	Supplemental			GPS Latitude/Longitude		
				Start	End	
Item	DWR UCIP Field Study			38.196429 °	38.196429 °	
				-121.698962 °	-121.698962 °	
DWR ID						
Comment Code						
Inspector Comment						
FS_ID:46813						
DS_ID:22735						
EP_NO: N/A						
Repair Type: Non-Urgent						
Crossing Status: Found						
UCIP Comments: Recommend owner contact CVFPB to provide updated owner info and obtain necessary permit for this crossing.						
FIELD_STRUCT_DESC: 18-inch steel pipe on WS. Steel standpipe on both sides of the levee. Temporary canvas about 2" below crown. Per 2015 Inspection Report provided by Herman Phillips, diesel motor found on WS and owner is Mr. Page Baldwin.						
FS Date: 8/13/2013

LS view: steel standpipe on levee slope.
